# Technician High Pressure Pump Guide for the 7.3 *Power Stroke* Engine

**HIGH PRESSURE PUMP**

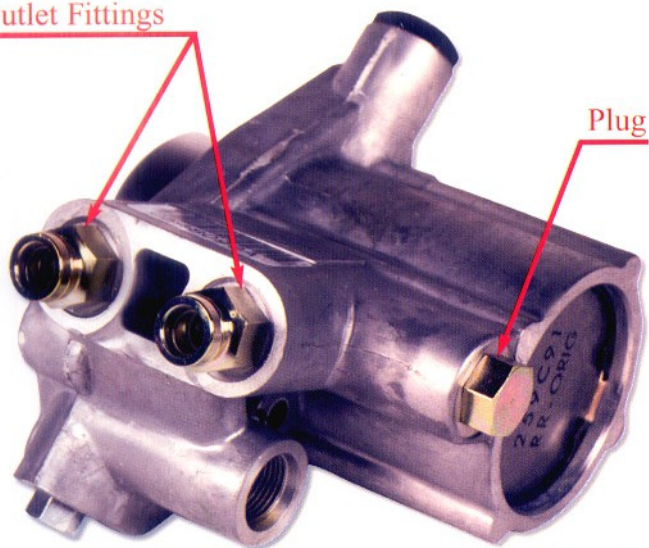
1

High pressure pumps with oil leaks at the fittings for the high pressure lines and the plug at the rear (see photo #1) can be repaired in the field using the following Ford part number 2C3Z-9G804-AA kit. This kit contains 3 o-rings, sealant, and instructions on how to clean and seal the fittings. Torque specs. for the fittings are also included.

Outlet Fittings

Plug

Note: Threads must be cleaned, sealant applied to the first 3 threads and the fittings and plug tightened to proper specs.

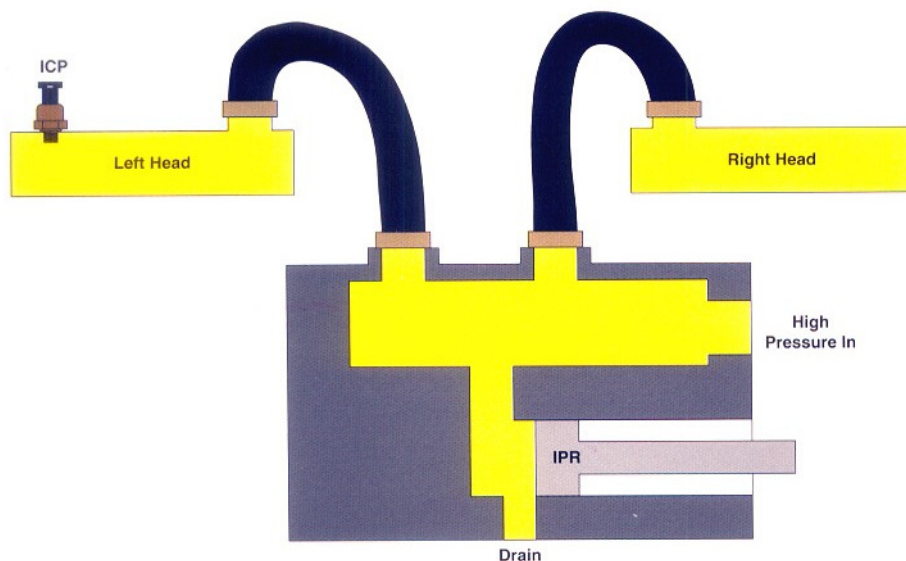
3

The IPR acts to increase ICP by restricting the path to drain.

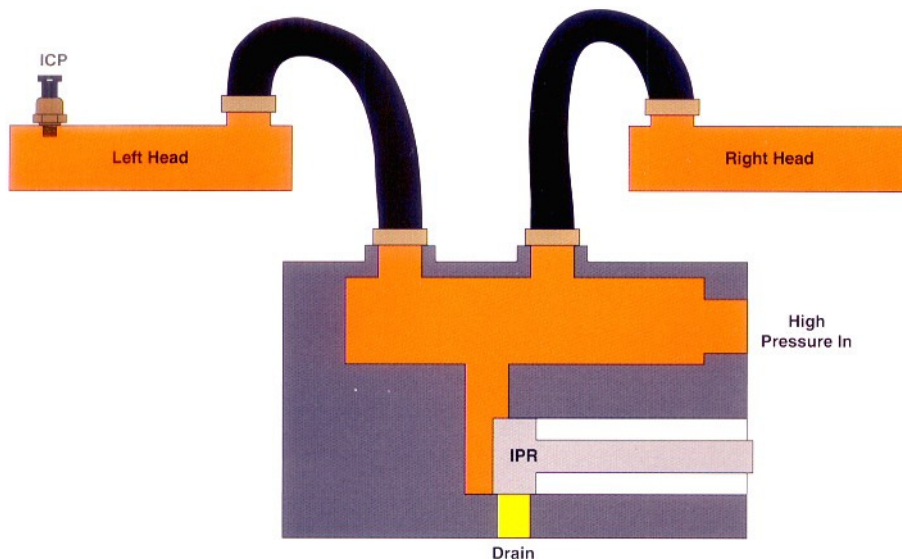
4

With max IPR% the ICP should be at its highest value.

The PCM attempts to increase ICP by raising the IPR%.

KOEO	14%
Crank to Start	Less than 30% typically with no leaks and engine starts
Idle	8 - 16% @ operating temperature
Full Load	Less than 50% with no ICP system leaks
No Start (Max Command)	54% for 94 to 97 MY 65% for 98 MY or newer

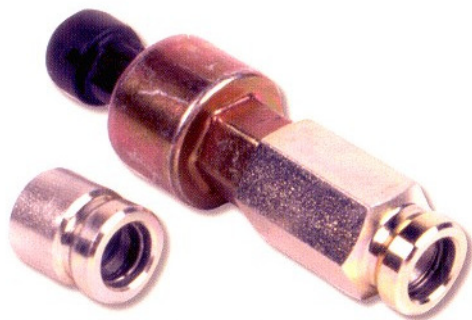
5

Use test plugs tool # D94T 6600 A for 94 thru 98 MY

Use test plugs tool # 303-627 & 303 - 628 (Kit #T99T-1000-E) for 99 MY and newer with quick connect connections.

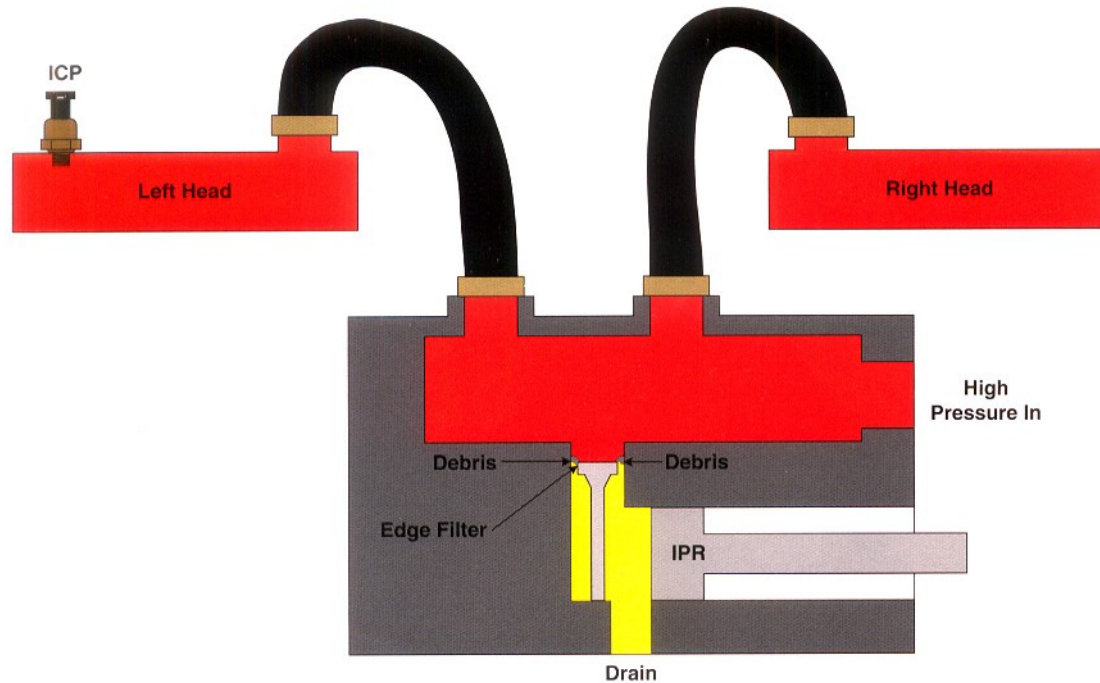
6

ICP more than 410 psi above command for at least 7.5 seconds can set a P1211 code. IPR with low duty cycle (less than 8% @ idle) and engine running, indicates a restriction in the drain circuit. This restriction is taking the place of the IPR valve, driving the IPR duty cycle lower, with higher than expected ICP. The excess restriction will be in the reservoir, front cover, stuck IPR valve, or debris above the edge filter. The drain path through the reservoir and front cover can be visually verified. Typically the pump or IPR must be replaced to repair this concern. Do not replace both components at the same time.

This often occurs after the oil pan is resealed where excess sealant is forced through the lube system (short circuit check valve) and trapped at the edge filter of the high pressure pump.

In mid 1995 the edge filter moved out of the IPR, upstream into the pump.

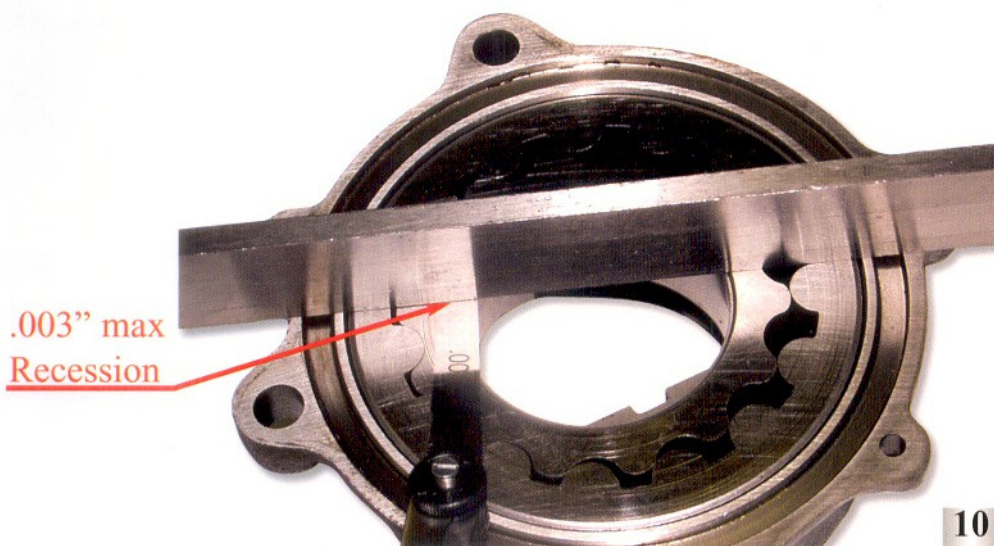
10

Recession greater than .003" causes long crank to start and/or stall.

To measure pump wear, place a straight edge across the pump housing and use a feeler gauge to measure clearance between the inner gear and the straight edge. A pump with excess gear recession will contribute to hard start issues.

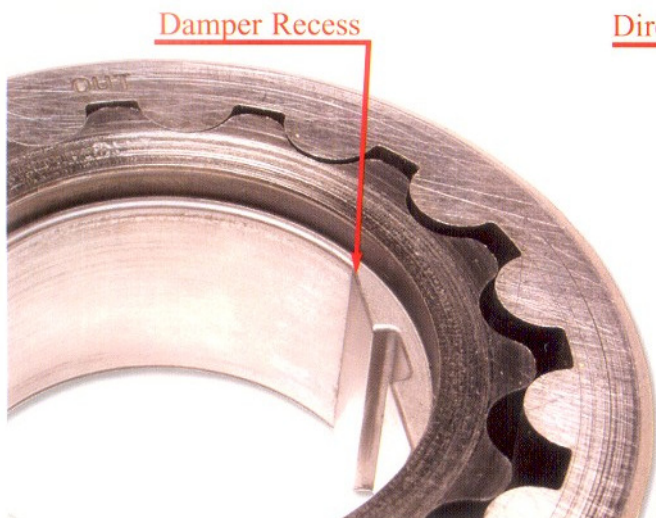
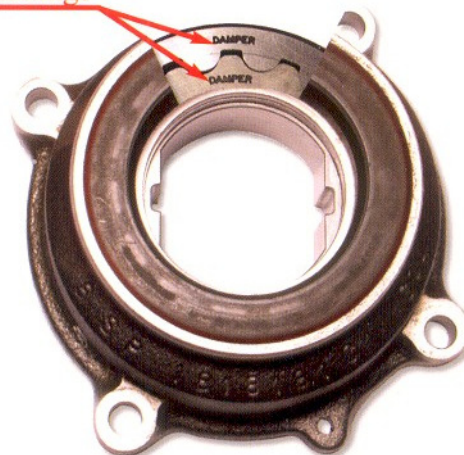
12

Directional Markings

When replacing the pump, the directional markings ("OUT" or "Damper") must face the vibration damper. If installed correctly there is a recess that the vibration damper fits into on the inner gear. If installed incorrectly, the inner gear will cause major damage to the front cover.

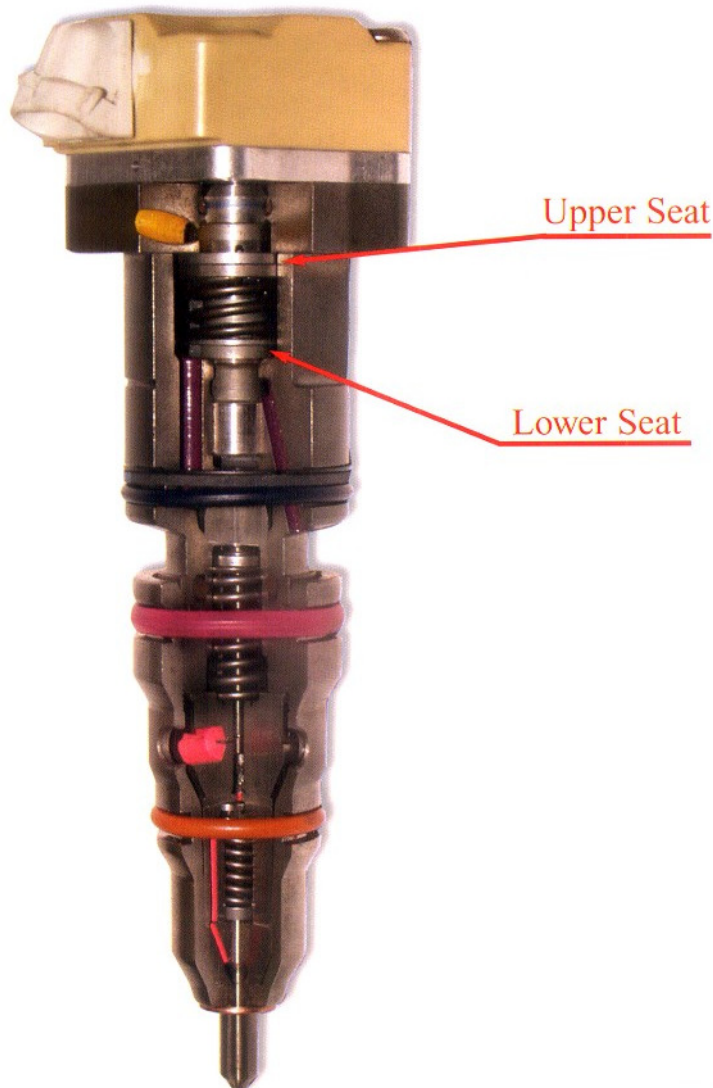
The audible sound heard while performing an injector buzz test is the poppet stopping at the upper and lower seat during actuation.
